Study of Atmospheric Corrosion of Structural Steel Surrounding the Palm Oil Industry in The Region of Eastern Coastal and Northern Aceh

Abstract

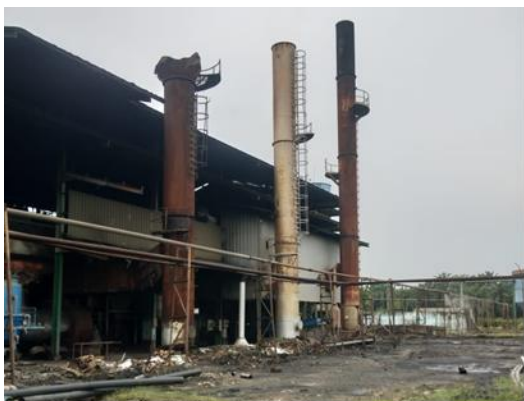
Figure 1. Infrastructure Corrosion on Industry of PTPN 1 Cot Girek (by research).

Figure 1 illustrates the corrosion and rust formation on industrial equipment, leading to material loss. This study experimentally maps atmospheric corrosion of structural steel around palm oil mills along Aceh's east coast and northern region. The objective was to assess the impact of palm oil processing on corrosion in both industrial and residential areas. The research focuses on four locations: the PTPN 1 Tanjung Seumantoh mill, PT Ensem Sawita, PT Anugerah Fajar Rezeki (AFR), and the PTPN 1 Cot Girek mill.

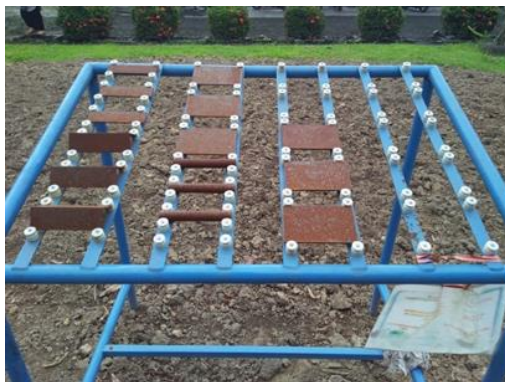
Figure 3. Test Specimens on Measurement Tray (location of palm oil industry of PTPN 1 Tanjung Seumantoh)

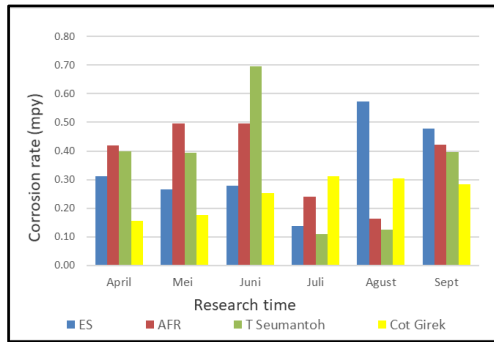
Figure 4 illustrates the correlation of corrosion levels on strip steel across four locations in eastern coastal and northern Aceh. After six months of exposure, the highest corrosion rate for strip steel occurred at the Tanjung Seumantoh palm oil mill, peaking at 0.60 mpy in the third month. A lower peak of 0.11 mpy was observed at the same location in the fourth month. In the other three locations, corrosion rates for strip steel remained relatively stable and similar throughout the data collection period, except for slight increases in the third and fourth months. The highest corrosion rates among these three locations were observed at PT AFR (0.62 mpy) and PT Ensew Sawita (0.56 mpy).

Figure 4. Graph for the relationship between corrosion rate of strips steel with study site

Across nearly all research locations, samples were exposed for six months. As shown in Figure 4, by the sixth month, the corrosion rate of strip steel across all locations stabilized, ranging from 0.28 to 0.50 mpy.

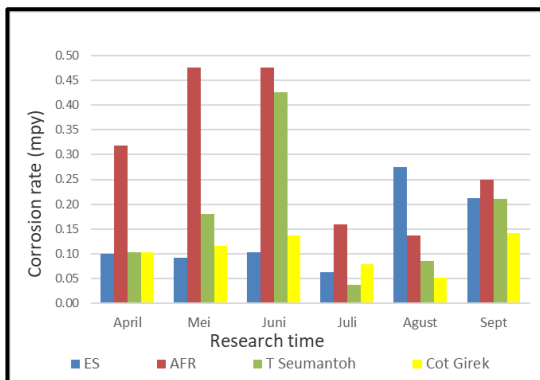
Figure 5 illustrates the corrosion rates of elbow steel across the four study areas after a six-month exposure period. The highest corrosion rate (0.55 mpy) was observed at PT Anugerah Fajar Rezeki in the third month. Conversely, the lowest corrosion rate (0.04 mpy) occurred at PTPN 1 Tanjung Seumantoh in the fourth month.

Figure 5. Graph for the correlation of corrosion rate elbow steel on research location

While the highest corrosion rate for elbow steel (0.56 mpy) was observed at the AFR palm oil mill during the third month of exposure, the average corrosion rate for elbow steel was lower than that of strip steel and the other steel types tested. The increased corrosion rates observed in the third month are attributed to the combined effects of humidity, temperature, and rainfall during that period.

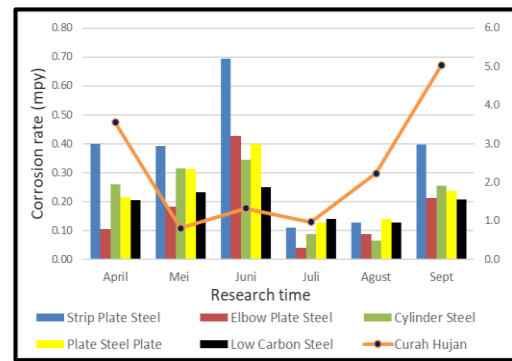
Regarding the figure 9 performed that level of corrosion rate which is exposing on five types of structural metal steel after giving the measurement during 6 (six) months, it performs the highest level of corrosion rate on steel with the strip plate metal and occurred at the third month of test specimens and exposed in the research location. In line with the last month after exposing, metal steel with the strip plate type performed the highest on level of corrosion rate comparing with another type of metal steel.

Figure 9. Level of corrosion rate on structural metal steel in PT Seumantoh

Elbow steel exhibited the lowest corrosion rate, reaching 0.03 mpy in the fourth month of exposure at the research sites. As shown in the graphs, elbow steel consistently demonstrated lower corrosion rates compared to the other steel types across all data sampling points.

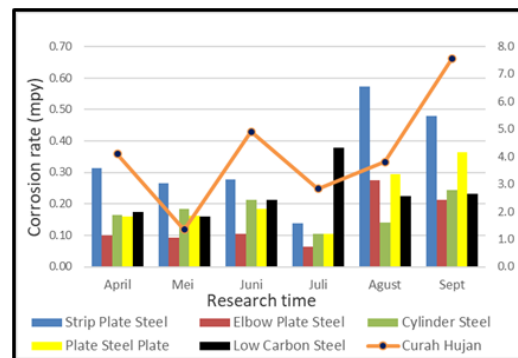
Figure 10 shows the corrosion rates of the five structural steel types after six months of exposure at the research sites, demonstrating a similar trend to that observed at PT Tanjung Seumantoh. At PT Ensem Sawita, strip steel exhibited the highest corrosion rate (0.58 mpy) in the fifth month, remaining the highest among all steel types at 0.50 mpy. The lowest corrosion rate (0.06 mpy) was recorded for elbow steel in the fourth month. The corrosion rates of the other steel types fell between those of strip steel and elbow steel, consistent with figure 10.

Figure 10. Level of corrosion rate of structural metal steel at PT Ensem Sawita

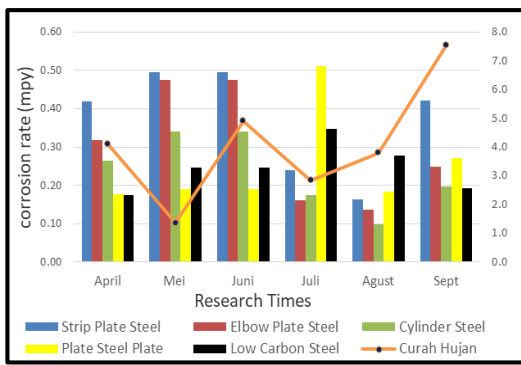
As depicted in figure 11, at PT AFR, cylindrical steel experienced the lowest corrosion rate in the fifth month of exposure. Conversely, elbow steel exhibited the lowest corrosion rate in the fourth month, with another low point also observed in the first month of measurement.

Figure 11. Level of corrosion rate of structural metal steel at PT AFR.

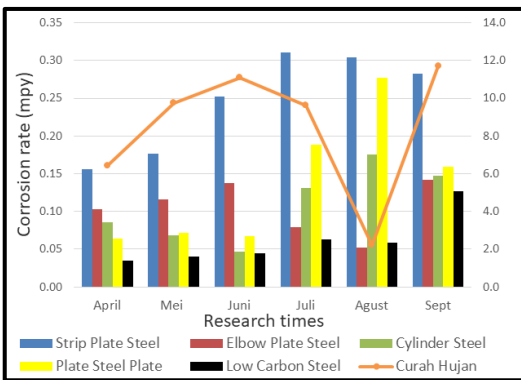
Figure 12 shows that strip steel consistently exhibited the highest corrosion rates across all measurement months. The highest corrosion levels for strip steel were recorded in the fourth (0.32 mpy) and fifth (0.31 mpy) months of exposure. These results for strip steel differ from those observed at the other research locations.

Figure 12. Level of corrosion rate on structural metal steel at PT Cot Girek

Low carbon steel consistently exhibited the lowest corrosion rates, starting at 0.03 mpy in the first month of exposure and remaining the lowest throughout the six-month test period. These rates for low carbon steel ranged from 0.03 to 0.14 mpy. The corrosion rates of the other steel types fell between those of low carbon steel and strip steel.
